THE RUNAWAY SOURCEHEAD

A 2800 pound sourcehead of a radiation teletherapy device fell suddenly and fatally injured a patient. Was this accident caused by defective mechanical design, inadequate maintenance, improper operation, or some combination of the above?

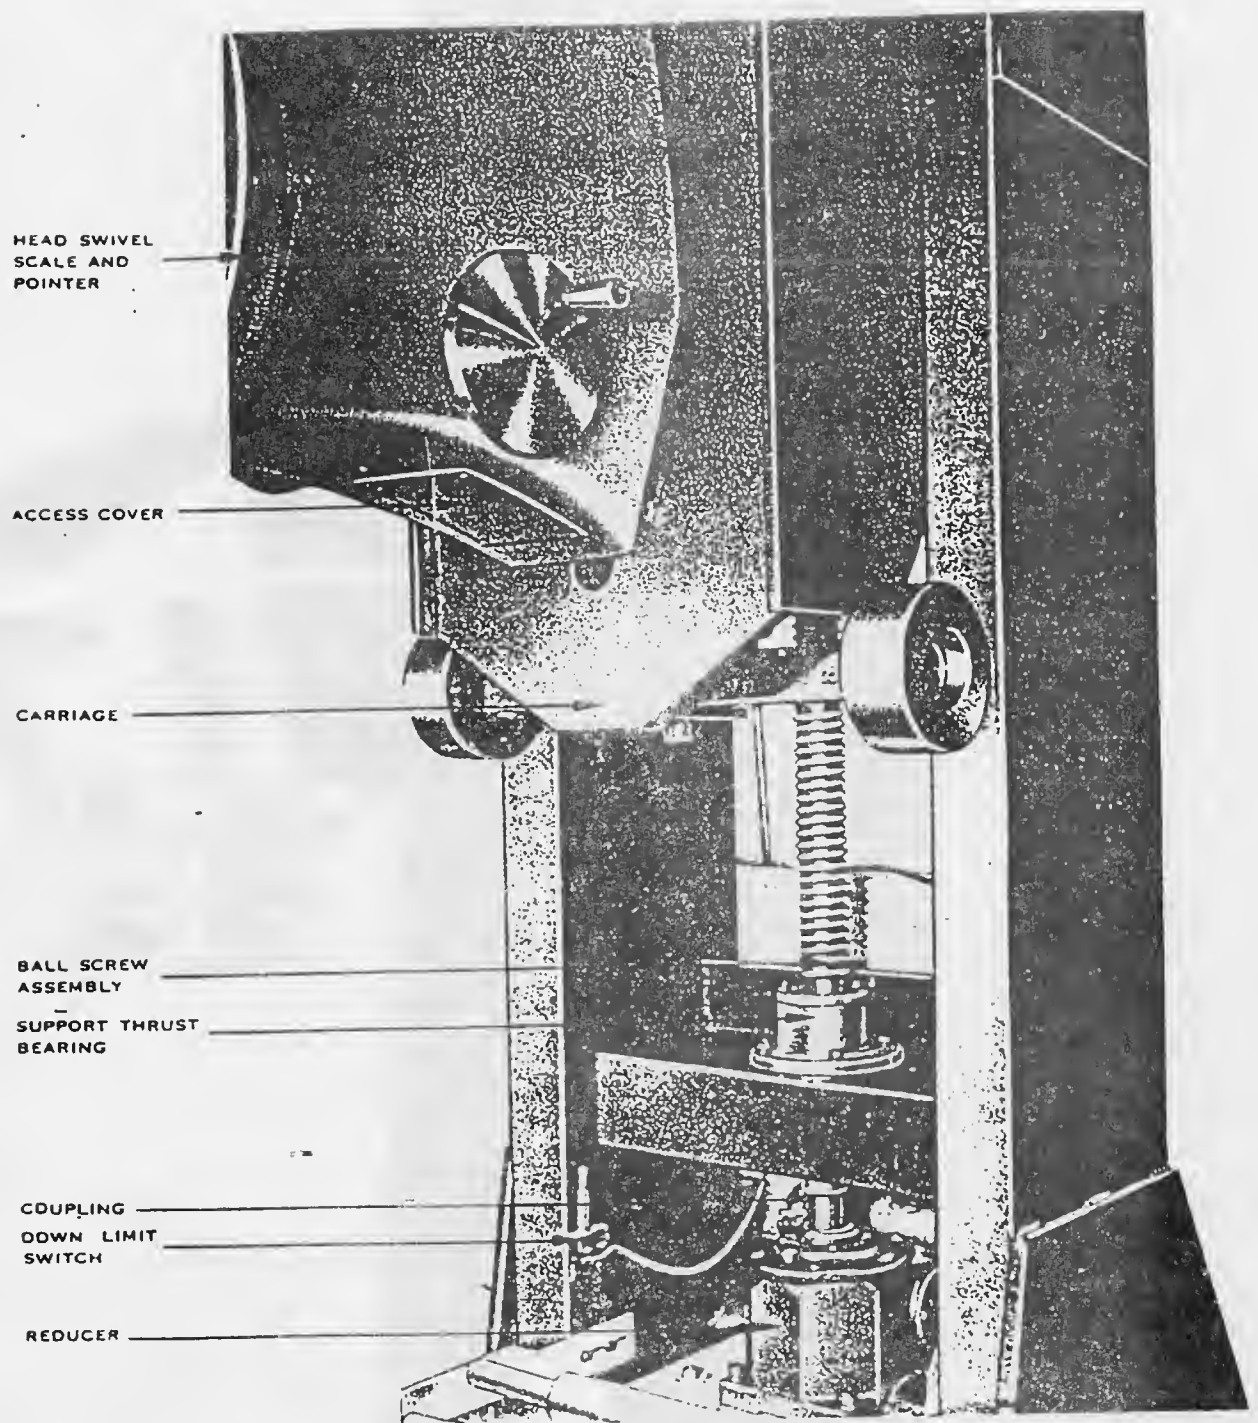
Exhibit 2 Elevation Drive - Front Cover Removed

Results showed that two setscrews in the upper half of a coupling in the drive system of the unit did not prevent the coupling from moving up the shaft end and disengaging from its lower half. This allowed the shaft (ball screw) to spin freely. The head and carriage ride up and down on the ball screw shaft as it turns, and thus was allowed to fall essentially unimpeded. There was no system for preventing uncontrolled descent in the event of the failure of this coupling. Additional damage to the other parts of the device occurred during the fall of the head and after its impact.

Evidence shows that at least one of the two setscrews was never tightened, and that both setscrews were loose at the time of the incident. Evidence does not clearly show whether the second setscrew was never tightened or whether it was tightened and worked loose.

The cause of the accident was the failure of the coupling halves to stay engaged. The upper half of the coupling was not secured in place by the setscrews and was allowed to work up the shaft. When the teeth disengaged from the teeth of the lower coupling, the ball screw shaft was allowed to spin freely under the weight of the sourcehead and carriage. This allowed the sourcehead and carriage to fall.

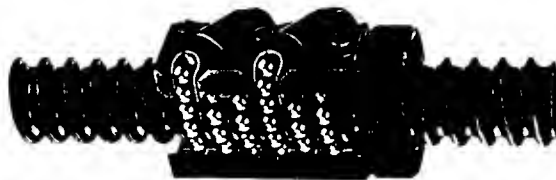
The very low friction of ball screws produces a significant characteristic. Unlike a sliding friction screw (automotive scissors type jacks, house jacks, etc) a ball screw can be back driven; that is, it is reversible. For this reason the ball screw itself, or shaft, must be restrained in order to prevent a load on the ball nut from driving (rotating) the screw.

Ball-bearing screw assembly with a portion of the nut cut away to show construction. (Courtesy Saginaw Steering Gear Division, General Motors Corporation.)
